Remembering 1976

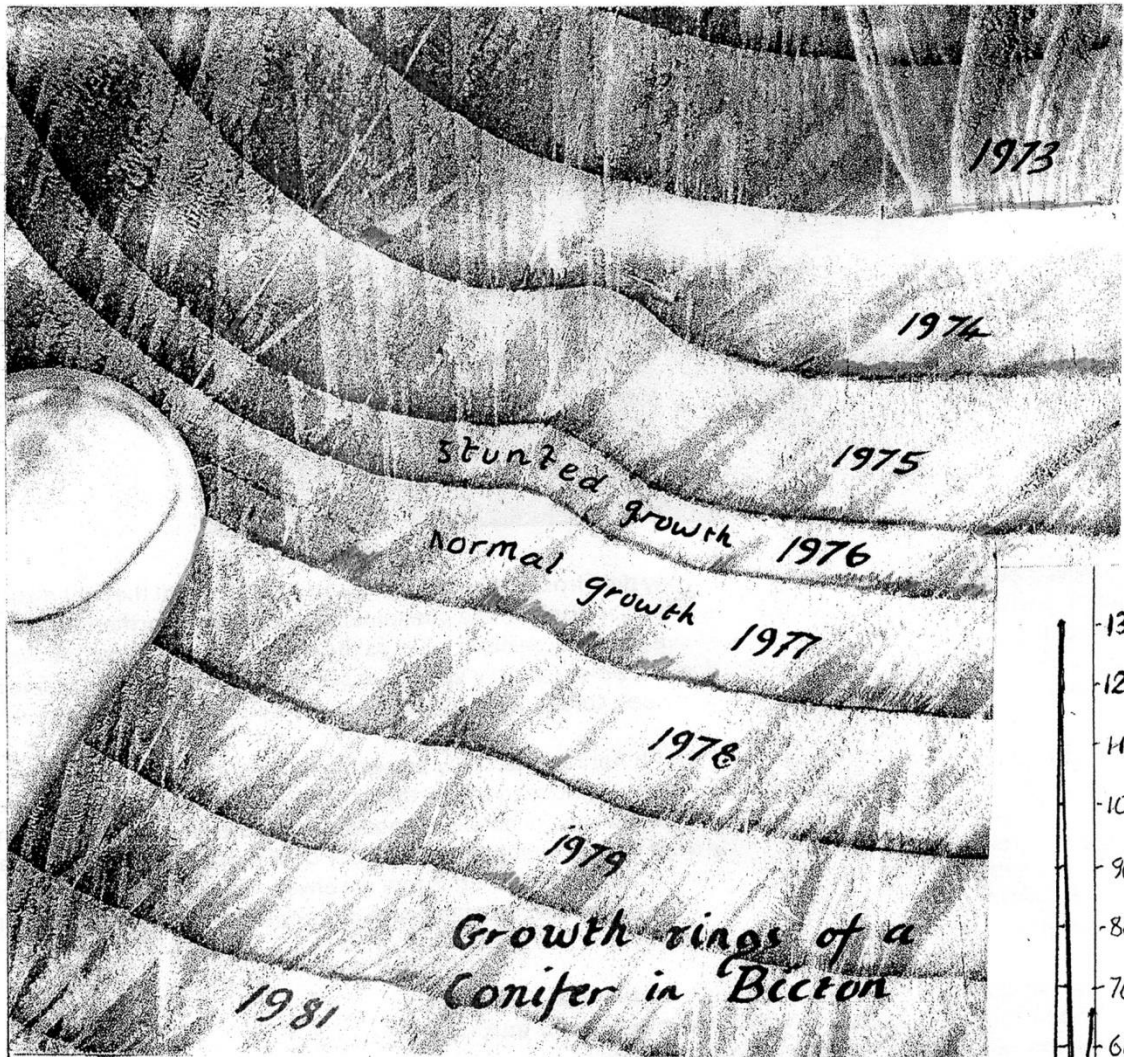
A Cedar Tree: cut section incl. 1976

The weather this year has prompted memories of 1976, when lawns were also parched, hosepipes banned and some forests burned (e.g. Haughmond Hill). Then, as now, the flow of the River Severn reflected the low rainfall, while local trees failed to lay down normal width of growth rings (July 2011).
