The Ground Beneath

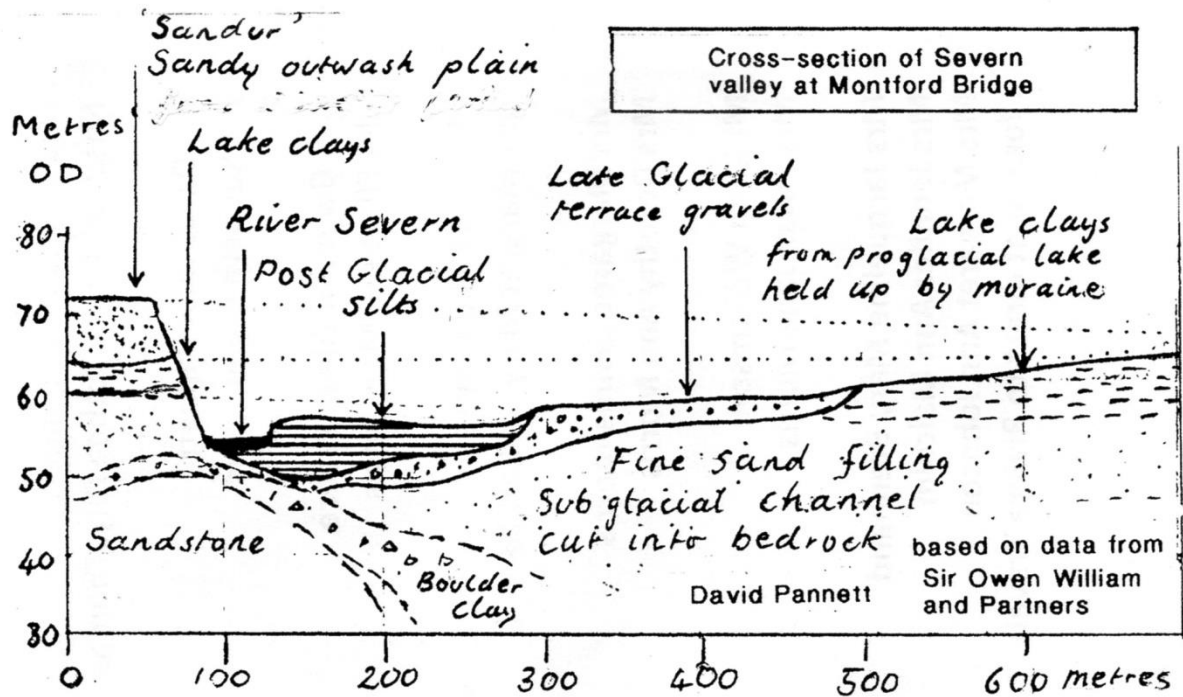
As in most of Bicton, here the solid sandstone remains hidden but, nevertheless, was important to the bridge engineers seeking a firm foundation for their piles. Unfortunately, at this very point, the sandstone has been cut by a deep channel carved by melt-water flowing under a thick ice cover. As the ice became thinner when conditions warmed, this old channel filled with soft sand. As a result bridge piles on the Bicton side had to be much longer, and it was still not clear if they actually reached solid rock!

As the ice front moved further back from Shrewsbury, it lingered here for some time, building up a 'moraine' which we know as Grange Bank. With further retreat, melt-water formed a lake between the ice and this moraine in which fine clay sediment accumulated. Since water flow and sediment load alternated with the seasons this formed thin layers called 'varves', which could record the life of that lake rather like tree rings.

As the River Severn began developing its valley downstream the lake drained away, but was replaced by an extension of the outwash plain or 'sandur' spreading out from Shrawardine and Ensdon, where a new moraine was being built up.

Further down-cutting by the river and the retreat of the ice front even further west into Wales saw the evolution of the winding course of the river we see today. At first the river created a large channel with its high rate of seasonal flow from melting ice and snow and cool wet climate generally. Its meander pattern thus consisted of wide loops with cliffs being eroded on the outside of the bends while gravel has built up on the inside.

With the arrival of true 'interglacial' conditions which we enjoy today, the river began to shrink, leaving those old gravel banks as a terrace while filling at least two thirds of its channel with clay and silt, helped by a thick growth of vegetation which trapped it.

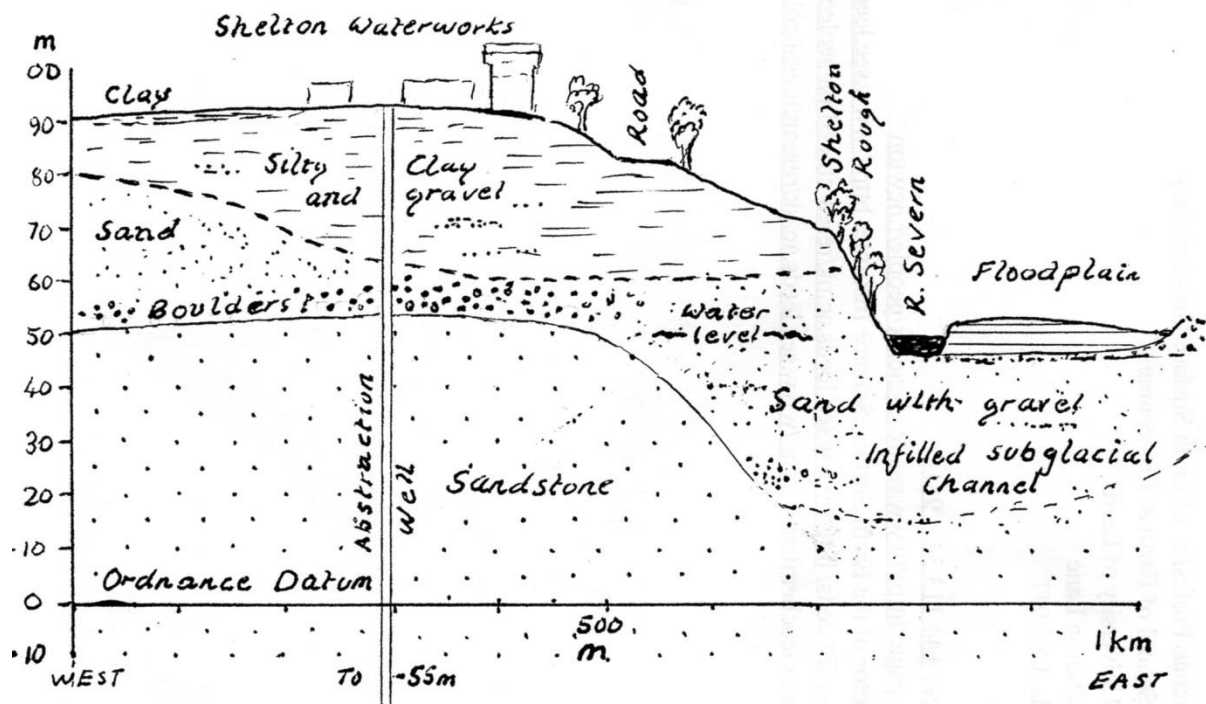
As at Montford Bridge, the river has cut a winding valley into soft glacial deposits, including a larger sand-filled channel cut into the underlying sandstone so that this site poses the same challenges to bridge builders as those at Montford Bridge!

Fortunately, the local geology offered a solution. Two wells were sunk into the underlying sandstone, producing much cleaner water. Then, as pumping draws down its level, it more easily filters in from the river via that sand-filled channel. The ease by which water seeps through to the wells was highlighted when a drum of cleaning fluid was spilt at nearby Shelton Hospital! Thus the water authorities express concern about too much development and road building near their site.

Above the aquifers, the section reveals the thick 'blanket' of mixed glacial deposits which cover much of Bicton parish. It varies both vertically and laterally and can support its own 'perched' water table independent of the porous sandstones beneath. Developers must be aware of this, but no doubt they will blunder on to fulfil targets by packing in the houses.
